# A case study of long-term field performance of check-dams in mitigation of soil erosion in Jiangjia stream, China

**Abstract** This paper examines the long-term field performance of the check-dams in mitigation of soil erosion in the Duozhao catchment of Jiangjia stream, southwest China. Since their construction between 1979 and 1982, the check-dams have been functioning effectively. The examination is made via comparisons between the environmental conditions of the Duozhao catchment with its adjacent Menqian catchment in the stream, because no check dams were constructed in the Menqian catchment. The examination is based on recent field investigations and aerial photograph analyses, and covers four aspects: (a) bed gradients of catchment channels; (b) stability of bank slopes; (c) rates of land

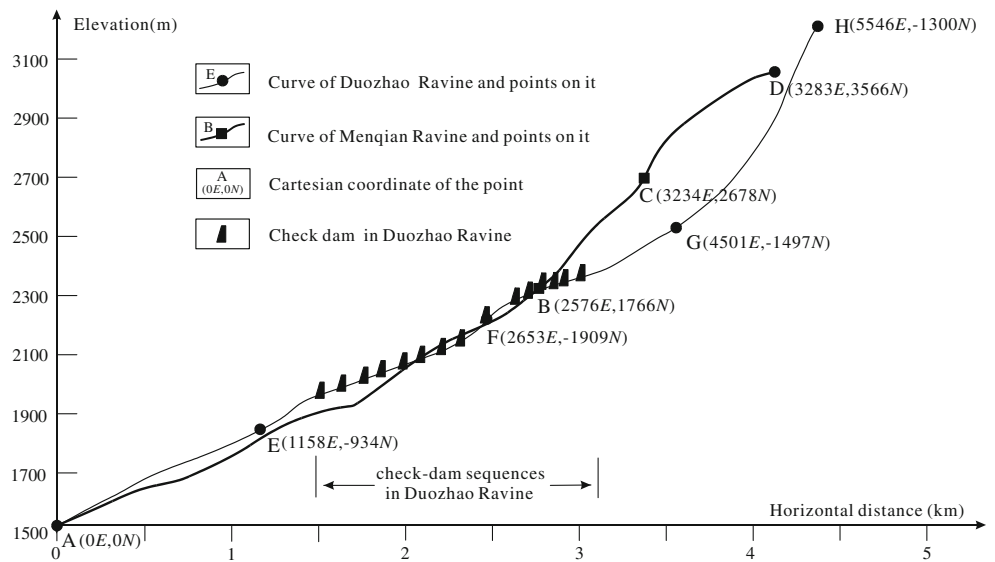
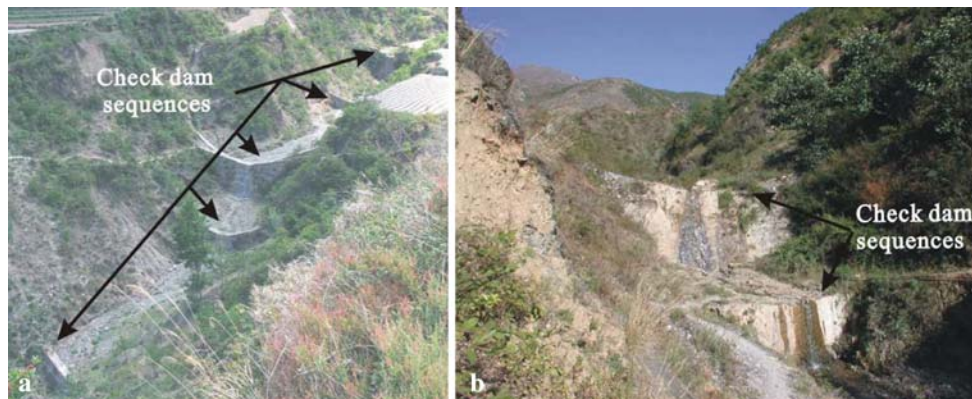
**Fig. 3** Longitudinal profiles of Menqian and Duozhao ravines. The position (3,243E–2,048N) refers to the local east and north coordinate system in the Fig. 2

Figure 3 shows the longitudinal profile of the Duozhao ravine following the locations A, E, F, G and H, and the check-dams in Fig. 2 and the longitudinal profile of the Menqian ravine following the locations A, B, C and D in Fig. 2. Figure 4a and b shows some of the check-dams in

Specifically, as shown in Fig. 3, the Duozhao ravine is slightly longer and higher than the Menqian ravine. The overall bed gradients of the two ravines are almost the same. The bed gradients of the two ravines from

the original point A to 4 km upstream are similar and gentle although the Menqian ravine has local bed zones with higher gradients. The Menqian ravine has its bed gradient sharply increase after the point B. The Duozhao ravine has its bed gradient sharply increase after the point G. The steep bed slope in the upper regions of the Duozhao

and Menqian ravines are mainly due to the presence of dolomites which have strong resistance to erosion. The middle region of the Duozhao ravine where the check-dams were constructed has the gentler bed gradients.

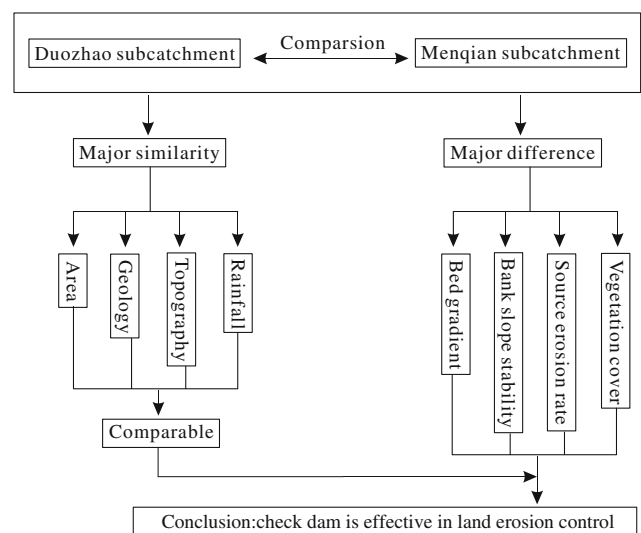
**Fig. 6** Approach for present investigation of the long-term performances of the check-dams in Jiangjia stream

Figure 6 shows a flow chart of the methodology for the investigation of the long-term performance of the check-dams in erosion mitigation in the Duozhao catchment. Table 2 shows a summary of the streambed gradients, channel lengths and plane areas for the Duozhao ravine, the Menqian ravines, and their tributaries. Figure 3 shows a comparison between the longitudinal profiles of the Duozhao and Menqian ravines. Figure 1 of ESM shows a comparison between the cross-sectional profiles of the Duozhao and Menqian ravines passing through the three points I, J and K. The exact locations of the points I, J and K are shown in Fig. 2. A detailed summary of the comparisons between the two catchments is further given in Table 3.

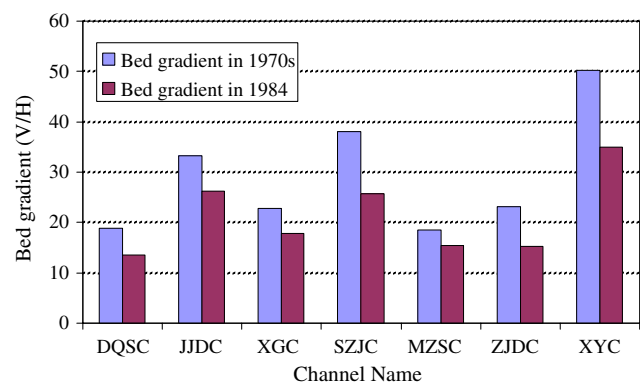
**Fig. 7** Comparison of bed gradients in 1970s before and in 1984 after the construction of the pointed check-dams in middle stream of Duozhao ravine (after Wu 1990). The channel names are given in Table 2 and Fig. 2

Figure 7 shows the percentage bed gradients of seven channels in the Duozhao catchment in 1970s and 1984 before and after the construction of the check-dams, respectively (Wu 1990). The channel bed gradient above each check-dam became gentle and was about 27.3% reduction of the original bed gradient. It is noted that the captured sediments above the catch dams were about 146,000 m<sup>3</sup> in total and were about 17.5% of the annual debris supply from the Duozhao catchment into the Jiangjia stream.

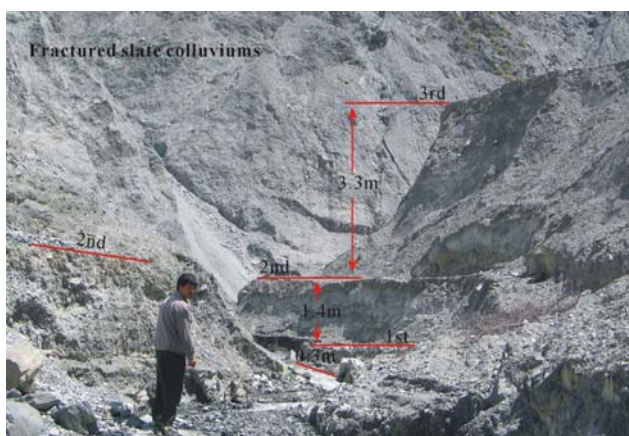
**Fig. 9** Site photograph showing fast cutting and severe erosion in Menqian ravine, position (1,660E, 1,280N)

Figure 9 shows an example of the seriously periodic downward cutting in the channel of the Menqian ravine. The position where the photograph in Fig. 9 was taken in 2004 is marked on Fig. 2. From Fig. 9, it is evident that there were at least three erosion levels. The channel was cut into the old debris flow deposits forming the channel bed. The total cutting depth was about 5–8 m. Figure 2 of ESM shows a typical example of the details of the steep bank slope profiles.

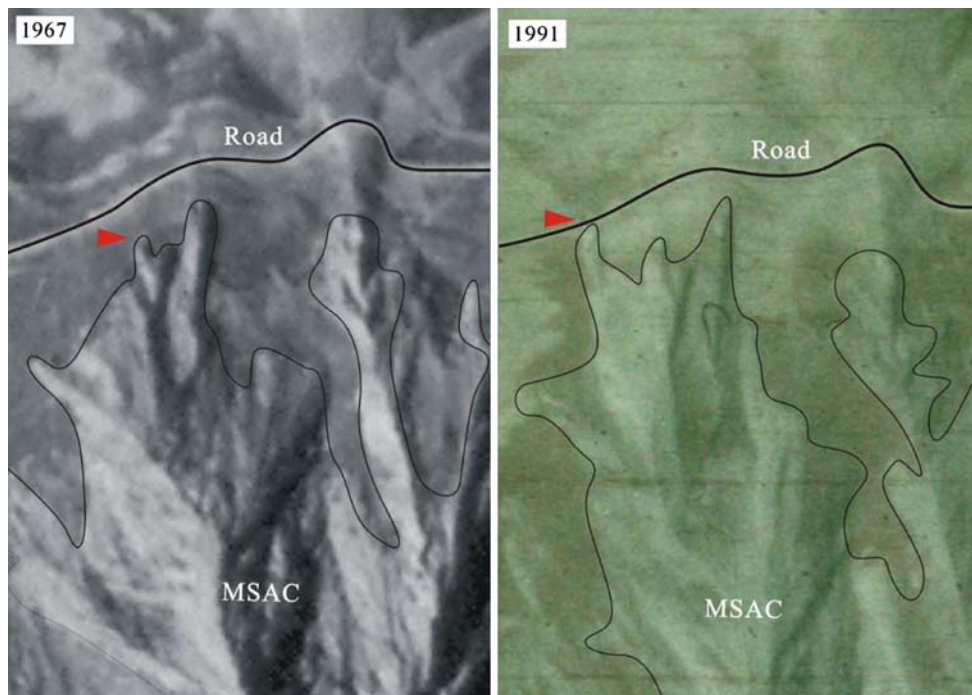
**Fig. 13** Aerial photographs in 1967 (a) and 1991 (b) for fast erosion rate in Mashanao channel (MSAC), position (3,650E, 3,150N), upstream of Menqian

Severe slope surface erosions have also occurred in the upstream areas of the Menqian and Duozhao ravines. Aerial photographs taken in 1967 and 1991 are used to illustrate the surface erosions and to compare the differences in the erosion rates of the two ravines. Figure 5 of ESM shows the 1967 and 1991 aerial photographs in Dahei channel in the Menqian upstream area. More channels can be observed on the 1991 photograph. Figure 13 shows the 1967 and 1991 aerial photographs in Mashanao channel in the Menqian upstream area. The eroded area in the 1991 photograph can be observed much closer to the road. Figure 6 of ESM shows the 1967 and 1991 aerial photographs in Jianjiaodi channel in the Duozhao upstream area. The 1991 photograph has less barren areas than the 1967 photograph, which indicates a slower erosion rate. Furthermore, the erosion distances and rates over the 24 years are estimated from each pair of the photographs in Fig. 13, Figs. 5 and 6 of ESM. The results are given in Table 4. From Table 4, it is evident that the erosion rates in Menqian upstream areas are greatly higher than those in Duozhao upstream areas.
